TEST REPORT

No. : XMIN2212009647CM

Sample Name : LIBERTY ROCK 40
Product Specification : SPC 4.2mm +1.0mm IXPE

No.	Test Item	Test Method	Result
1	Improvement of impact sound insulation	ISO 10140-1:2021 ISO 717-2:2020	$\Delta L_w = 20 \text{ dB}$

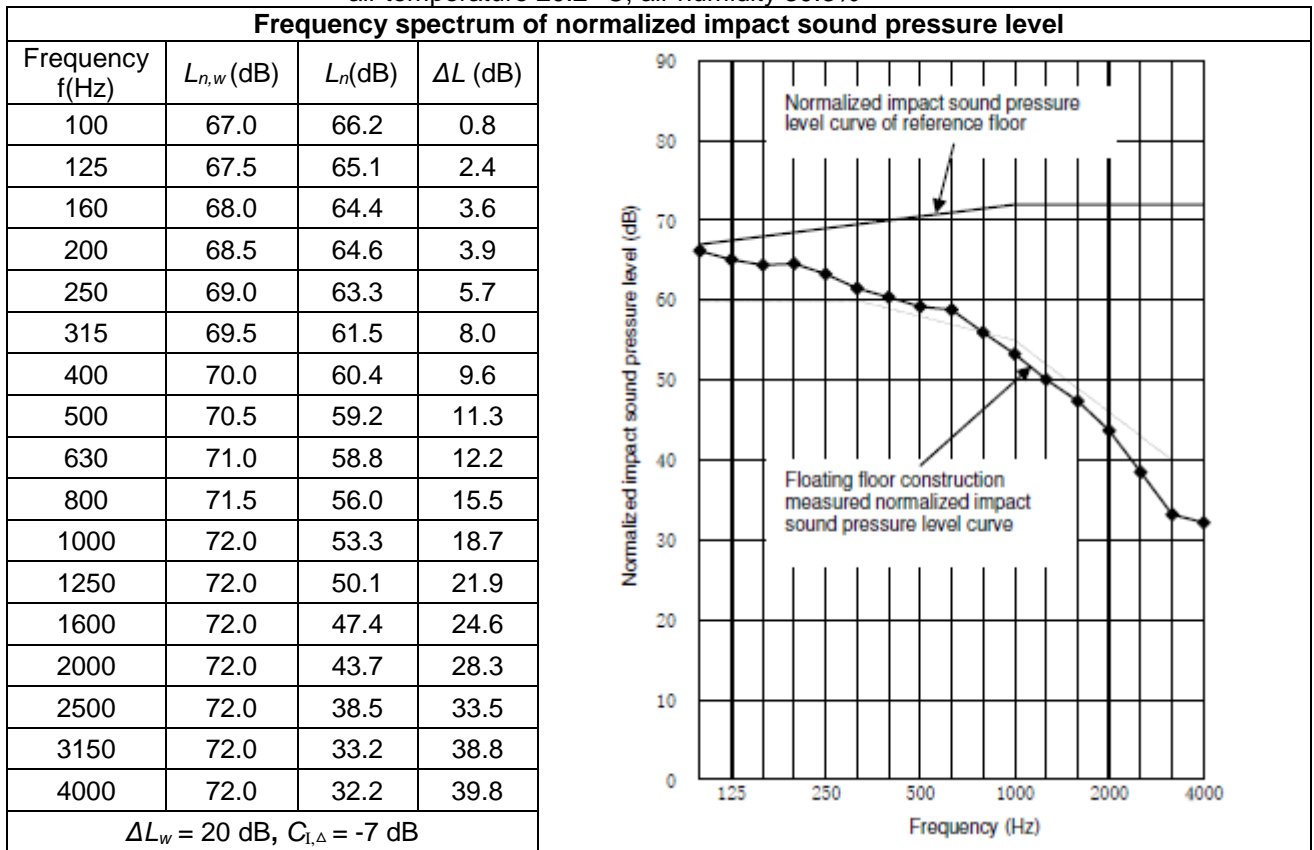
- Sample Description : Flooring (see the photo)
Total Thickness:5.2mm, surface density: about 8.6 kg/m²
- Test conducted : ISO 10140-1:2021, ISO 717-2:2020
- Project description : No decoration of sample surface and installation assembled directly.
The test specimen was covered on a 150mm concrete floor, testing area 11.3m²
- Test Equipment : RTA840 system
- Test Environment : Source room volume 125m³, receiving room volume 100m³,
air temperature 20.2 °C, air humidity 30.3%

1. $L_{n,w}$ as the weighted normalized impact sound pressure level
2. L_n as the measured normalized impact sound pressure level
3. The above test project/method was carried out by subcontractors.
